## SAFETY FOCUS INTERSECTIONS – WHITE PAPER

**Date:** March 2, 2011 Project #: 10633.07  
**To:** Jim Olson  
City of Ashland  
**cc:** Project Management Team  
**From:** Susan Wright, P.E. and Erin Ferguson  
**Project:** City of Ashland Transportation System Plan Update  
**Subject:** Safety Focus Intersections – White Paper

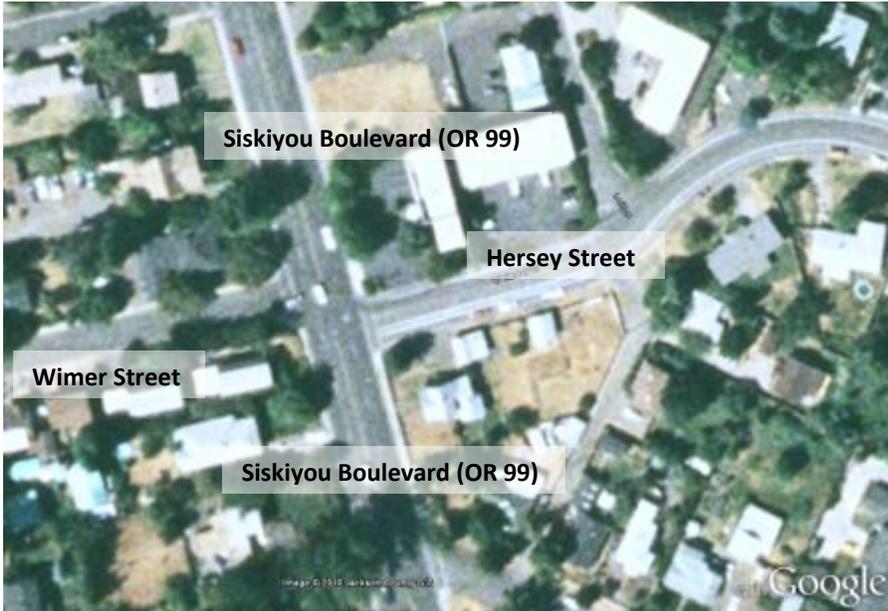
## Exhibit 1 North Main Street (OR 99)/ Hersey Street-Wimer Street

- At the intersection, North Main Street has a four-lane cross-section with two through lanes in each direction.
- Hersey Street and Wimer Street are offset such that Hersey Street is slightly further south than Wimer Street.
- The offset alignment of Hersey Street and Wimer Street is a negative offset, which means the left-turn movements from North Main Street onto the minor streets occur behind (rather than in front) of each other. A negative offset creates additional conflicts and is a harder task for a driver as a result it is associated with higher occurrence of crashes.

- The majority of the reported crashes were rear-end crashes or turning crashes;
- The majority of the turning crashes (i.e., 18 out of 21 reported turning crashes) occurred when motorists waiting to turn left off of North Main Street (OR 99) onto a minor street turned in front of on-coming traffic;

- Slightly more than half of the reported rear-end crashes (i.e., 7 out of 13 reported rear end crashes) occurred when motorists waiting to turn left off of North Main Street (OR 99) were hit from behind by a motorist traveling straight on North Main Street (OR 99);

- Four crashes at the intersection were related to bicyclists or pedestrians attempting to cross North Main Street (OR 99); and
- Three crashes at the intersection were related to motorists misjudging gaps in traffic or failing to see approaching traffic while attempting to cross North Main Street (OR 99) from Hersey Street to Wimer Street or the reverse.

- **Add left-turn pockets and/or right-turn lanes on North Main Street (OR 99)** – The left-turn pockets would provide refuge for motorists waiting to turn left off of North Main Street (OR 99) and may help reduce the rear-end crashes on North Main Street (OR 99). Similarly, the right-turn lanes on North Main Street (OR 99) at the intersection would provide refuge for vehicles slowing to turn right.
- **Consider a traffic signal or roundabout at the intersection** – A traffic signal and/or roundabout would help facilitate the left-turn movements onto and off of North Main Street (OR 99) at this intersection. An engineering study is needed to determine whether a traffic signal or roundabout would be appropriate or effective for this location and if so, which type of traffic control would be most appropriate.

- **Convert access to Hersey Street and Wimer Street to right-in/right-out access only** – Restricting access to these minor streets to right-in/right-out only would eliminate collisions related to motorists turning left onto or off of North Main Street (OR 99) as well as crashes related to motorists crossing North Main Street (OR 99) from Hersey Street to Wimer Street or the reverse. Left-turn access to and from North Main Street (OR 99) could be served to the north through the signalized Maple Street/ North Main Street (OR 99) intersection or to the south through the signalized North Main Street (OR 99)/Laurel Street and/or the North Main Street (OR 99)/Helman Street intersections. This countermeasure is noted because 28 of the 42 reported crashes at the intersection were related to left-turning or crossing maneuvers. ***As part of the temporary road diet project, this intersection is recommended to be converted to a right-in/right out/left-in (for the movement from North Main Street to Hersey) access. This modification to access would be on a temporary basis as part of the temporary road diet; the combination of the off-set intersections with a center left-turn lane increases conflicts and potential for crashes. .***

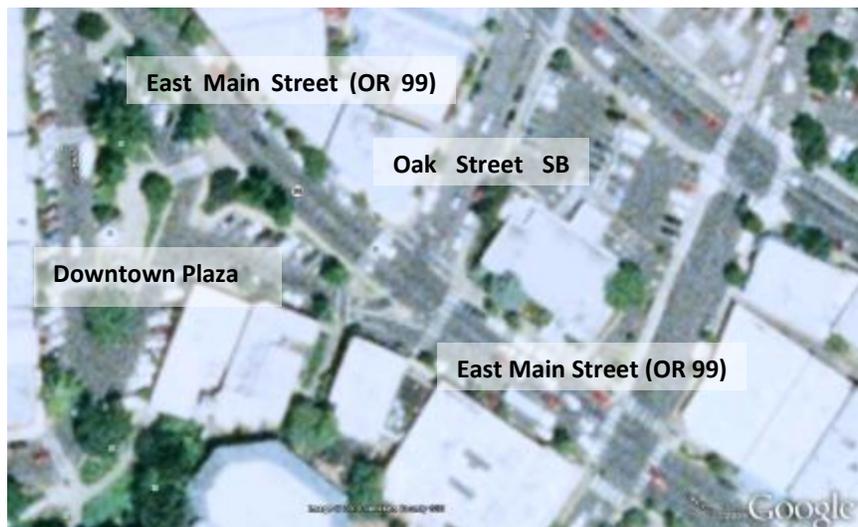
## Exhibit 2 East Main Street (OR 99)/Oak Street

- Opposite Oak Street is a driveway from a downtown off street parking lot and pedestrian area (i.e., the downtown plaza area), which intersects East Main Street (OR 99) at a skewed angle.

- The skewed approach from the Downtown Plaza area has a left-turn lane that allows motorists to turn onto Oak Street to travel north and a through-lane that is uncontrolled and becomes the third southeast-bound lane on East Main Street (OR 99).

- Over half of the crashes reported at the intersection were turning related crashes and of those the majority involved improper turns in which motorists were distracted and/or failed to yield the right-of-way appropriately; and
- The majority of crashes at the intersection were property damage only crashes, which generally indicates the crashes that do occur are occurring at slower speeds as motorists navigate a busy urban area.

One potential countermeasure to reduce conflicts and countermeasures at this location is to eliminate the third lane on East Main Street, which is added to accommodate free flow traffic from the Downtown Plaza onto East Main Street. Providing an exclusive lane for the vehicles exiting the Downtown Plaza discourages drivers from confirming eastbound drivers on East Main Street are not changing lanes into the third lane. It also does not give motorists exiting from the Downtown Plaza a reason to stop or slow down as they enter East Main Street, which can result in higher than desired speeds or inattention from motorists. Removing the third lane and bringing all vehicles exiting the Downtown Plaza Area to a stop at a location across from Oak Street will eliminate the uncontrolled conflict and require motorists to look for a gap in traffic before entering East Main Street. Removing the third lane on East Main Street also would shorten the crossing distance for pedestrians. ***This treatment is consistent with the Downtown Plan.***

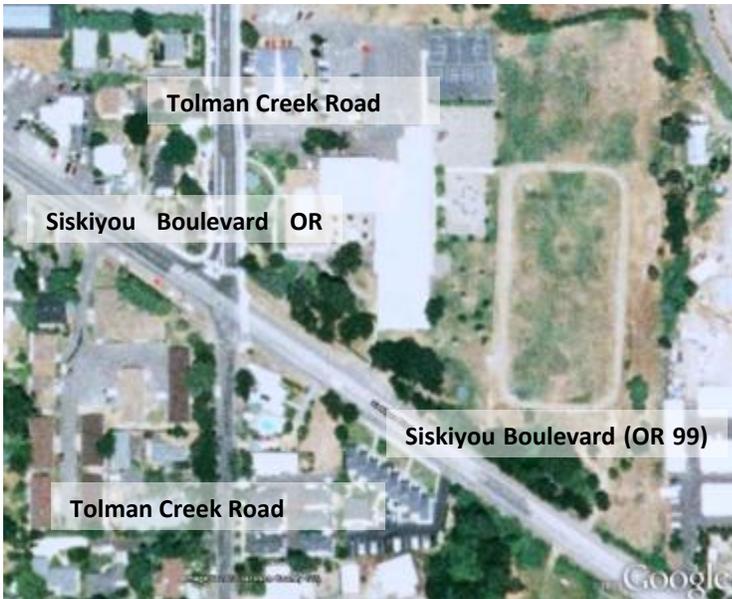
Exhibit 3 Siskiyou Boulevard (OR 99)/Tolman Creek Road

- The intersection is skewed with Tolman Creek Road oriented north-south and Siskiyou Boulevard (OR 99) oriented northwest-southeast.
- There is a flashing amber light at the intersection and marked crosswalks along the northern, southern, and southeastern legs of the intersection.

- Siskiyou Boulevard (OR 99) has a two-lane cross-section with relatively wide shoulders.
- The posted speed limit on Siskiyou Boulevard (OR 99) changes from 45 mph to 35 mph when approaching the intersection from the southeast.

- The majority of the reported crashes were angle crashes; and
- The majority of the angle crashes occurred when vehicles were attempting to cross Siskiyou Boulevard (OR 99) or turn onto Siskiyou Boulevard (OR 99); motorists appear to misjudge approaching vehicle speeds or fail to see approaching vehicles.

Based on the physical conditions at the intersection and the reported crashes, drivers appear to have difficulty judging approaching speeds or seeing approaching vehicles. Potential countermeasures include:

- **Prohibit parking on Siskiyou Boulevard (OR 99) in the vicinity of the intersection** - Based on photos on Google Earth, parking on the shoulder of Siskiyou Boulevard (OR 99) appears to be permitted or if it is prohibited, violations are occurring. The presence of parked vehicles may be inhibiting motorists' sight distance at the intersection. Prohibiting parking and/or enforcing the parking prohibition in the vicinity of the intersection would help improve sight distance and potentially help reduce crashes.

- **Conduct a speed study and investigate potential speed reduction treatments** - A pertinent next step could be to conduct a speed study to determine prevailing vehicle speeds on Siskiyou Boulevard (OR 99) and if they are higher than appropriate for the desired conditions. This could be the case given the change in the posted speed limit from 45 mph to 35 mph on approach to the intersection. This is also the area in which Siskiyou Boulevard

(OR 99) begins to change in function from a non-urban highway-type function to a facility passing through an increasingly urban area that provides access as well as mobility to travelers. If prevailing speeds are higher than desired on approach to the intersection, speed reduction treatments may be appropriate and may serve as an opportunity to change the physical cross-section of Siskiyou Boulevard (OR 99) to visually inform drivers the change in roadway function.

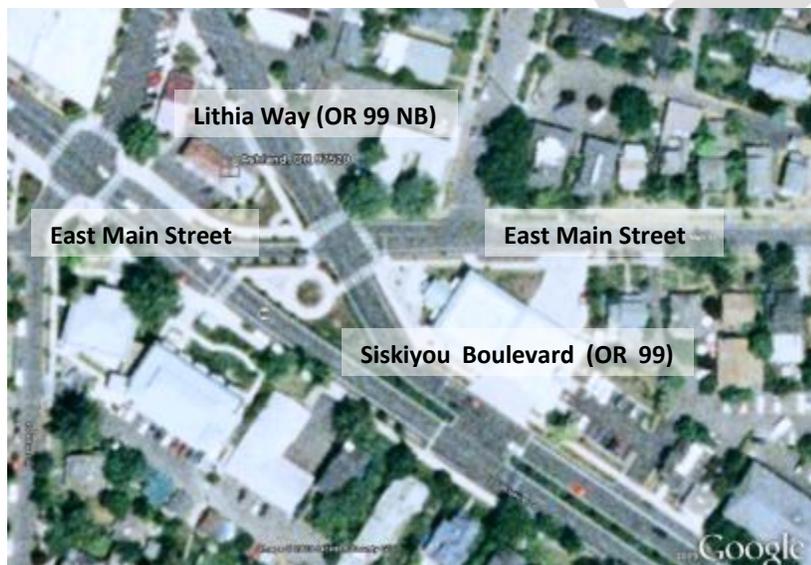
Exhibit 4 Siskiyou Boulevard (OR 99)/Lithia Way (OR 99 Northbound)/East Main Street

- The majority of reported crashes are rear end crashes that occurred when motorists were following too close or were distracted;
- The angle/turning crashes at the intersection occurred when motorists disregarded the traffic signal and/or failed to yield to pedestrians in the crosswalk.

In general, the types of crashes noted above are consistent with what is expected to occur at signalized intersections. Potential countermeasures include:

- **Conduct a roundabout feasibility study** – Research regarding roundabouts in the United States has found converting traffic signals to roundabout controlled intersections can reduce total crashes up to 48% depending on the number of lanes in the roundabout<sup>1</sup>. As noted in the Roundabout White Paper, they are also useful for efficiently serving U-turning traffic, which is necessary at couplet terminuses and they serve as an aesthetically pleasing gateway treatment into downtown areas. This particular location may be challenging given the angles at which the roadways intersect and the right-of-way constraints. A roundabout feasibility study would be able to determine the potential safety and operations benefits as well as how or if a roundabout could fit within the right-of-way constraints. ***It should be noted that the Downtown Plan identifies a signal or roundabout to improve this intersection and includes a preliminary double lane roundabout design.***

- **Consider installing red-light running cameras** - A potential countermeasure that may help reduce crashes particularly those related to disregarding the traffic signal could be automated enforcement such as red-light running cameras. It is important to note while red-light running cameras tend to help reduce crashes related to disregarding the traffic signal, in some instances they have been found to increase the occurrence of rear-end crashes.

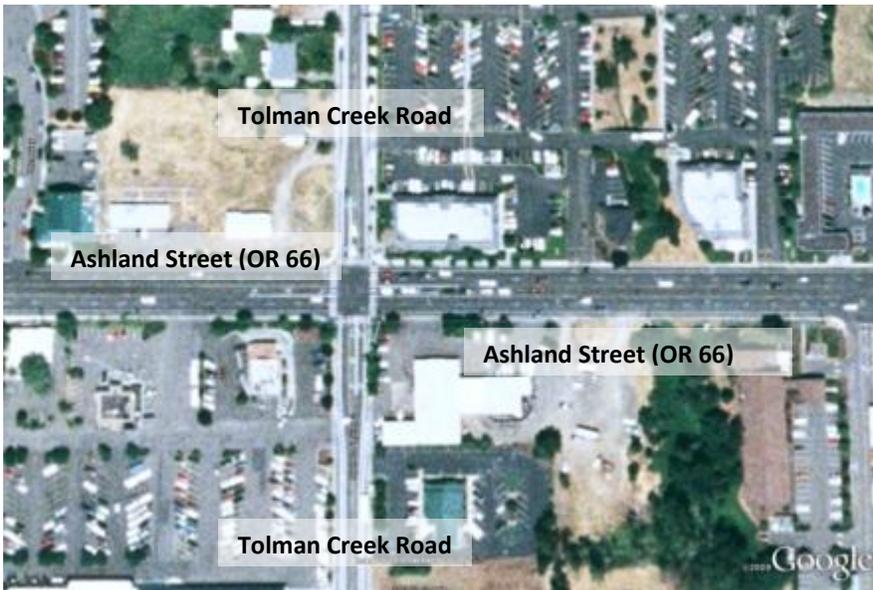
#### Exhibit 5 Ashland Street (OR 66)/Tolman Creek Road

- Crashes tend to be rear end, angle or turning crashes;
- The majority of the rear end crashes occurred when motorists failed to stop or were following too close to vehicles in front of them;
- The majority of turning crashes occurred when motorists turned from the wrong the lane; and
- The majority of angles crashes occurred when motorists disregarded the traffic signal control and/or were distracted or inattentive.

The current intersection form does not exhibit obvious features for improvement. The types of crashes reported for the intersection tend to be consistent with the types expected to occur at signalized intersections. One potential countermeasure would be to install red-light running enforcement cameras, which tend to reduce crashes related to disregarding traffic signals. However, red-light enforcement cameras have also been found to increase rear-end crashes. Therefore, additional information regarding why motorists are currently failing (and historically have failed) to stop to avoid other stopped vehicles would be helpful in determining whether or not red-light enforcement cameras would be appropriate for this intersection as well as what other countermeasures could be considered.

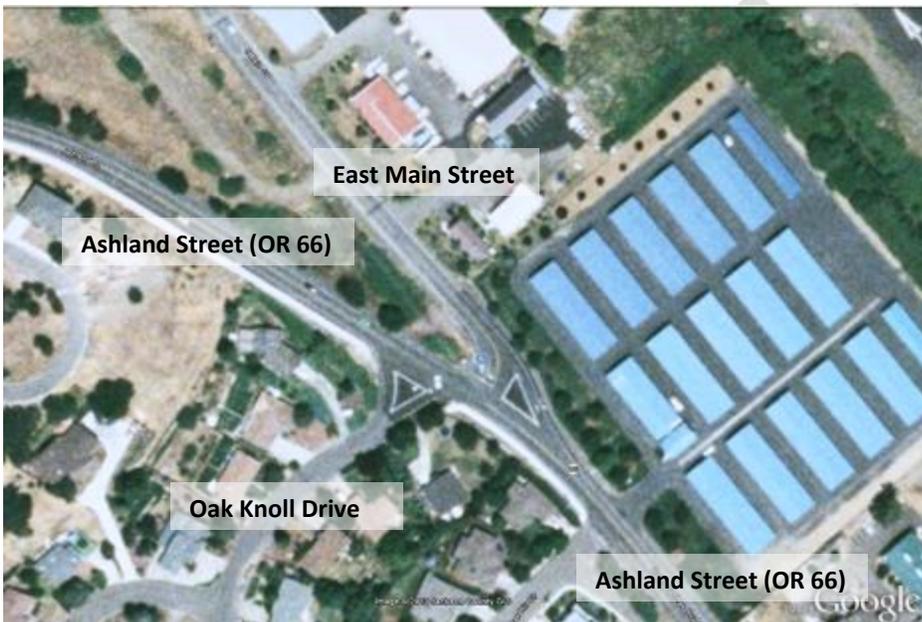
Exhibit 6 Ashland Street (OR 66)/East Main Street/Oak Knoll Drive Intersection

- The intersection is skewed and occurs along a horizontal curve.

- The minor streets (East Main Street and Oak Knoll Drive) are offset from one another. Similar to the Hersey-Wimer/North Main Street (OR 99) intersection, the offset is a negative offset meaning the left-turns onto the minor streets occur behind each other rather than in front of each other. As noted above, this creates additional conflicts points, is a more difficult task for drivers and is associated with a higher occurrence of crashes as a result.
- There is a downhill grade when traveling on Ashland Street (OR 66) approaching the intersection from the northwest.
- Ashland Street (OR 66) is a two-lane cross-section (one travel lane in each direction) at the intersection.

- The majority of the crashes are rear end crashes or angle/turning crashes;
- The rear end crashes tend to occur when a vehicle is stopped on Ashland Street (OR 66) waiting to turn left onto East Main Street or Oak Knoll Drive; and
- The angle/turning crashes tend to occur when a vehicle is attempting to cross Ashland Street (OR 66) while traveling from East Main Street to Oak Knoll Drive or the reverse. Crashes also tend to occur when a vehicle turning off of or onto Ashland Street (OR 66) fails to yield or give the right-of-way to through traffic on Ashland Street (OR 66).

Based on the physical conditions in the field as well as the crash types and events documented in ODOT's crash data, it appears motorists may have minimum or inadequate sight distance at the intersection. A lack of sight distance could be contributing to the rear end crashes on Ashland Street (OR 66) because motorists traveling along Ashland Street (OR 66) do not have adequate time and distance to identify and react to vehicles stopped in the roadway waiting to turn. Similarly, motorists attempting to turn to, from, or crossing Ashland Street (OR 66) may not have adequate sight distance

to identify and react to acceptable gaps in traffic for turning and crossing maneuvers and/or may misjudge gaps.

- **Conduct a sight-distance evaluation at the intersection** – It would be pertinent to conduct an engineering study to determine the amount of sight distance available at the intersection for the turning movements onto and off of Ashland Street (OR 66) as well as the sight distance available for motorists approaching the intersection on Ashland Street (OR 66). Findings from such a study would help guide decisions related to what types of countermeasures are considered for the location.

- **Add left-turn and right-turn pockets on Ashland Street (OR 66)** – These would provide a refuge for vehicles stopped waiting to turn left off of Ashland Street (OR 66) and for vehicles slowing to turn right off of Ashland Street (OR 66).

- **Investigate prevailing vehicle speeds on Ashland Street (OR 66) and consider treatments to reduce vehicle speeds** – The prevailing vehicle speeds on Ashland Street (OR 66) may be higher than is appropriate for the roadway geometry. A speed study could be used to determine if the 85<sup>th</sup> percentile speed is higher than the posted speed and/or the appropriate speed based on the sight distance at the intersection. If prevailing vehicle speeds on Ashland Street (OR 66) are higher than those warranted for the sight distance at the intersection, treatments to slow vehicle speeds on approach to the intersection could be explored. *NCHRP Report 613 Guidelines for Selection of Speed Reduction Treatments at High-Speed Intersections* contains information on potential treatments.

- **Increase intersection sight distance** – This could be accomplished by adjusting the horizontal and/or vertical alignments of the intersecting roadways. Whether or not realigning or adjusting the horizontal and/or vertical alignments for the intersection is feasible and the potential value it would provide should to be explored in an engineering study.
